ACRE POND DAM

NDI ID NO. PA-00973
DER ID NO. 58-34

PHASE I INSPECTION REPORT
NATIONAL DAM INSPECTION PROGRAM

AUGUST 1981

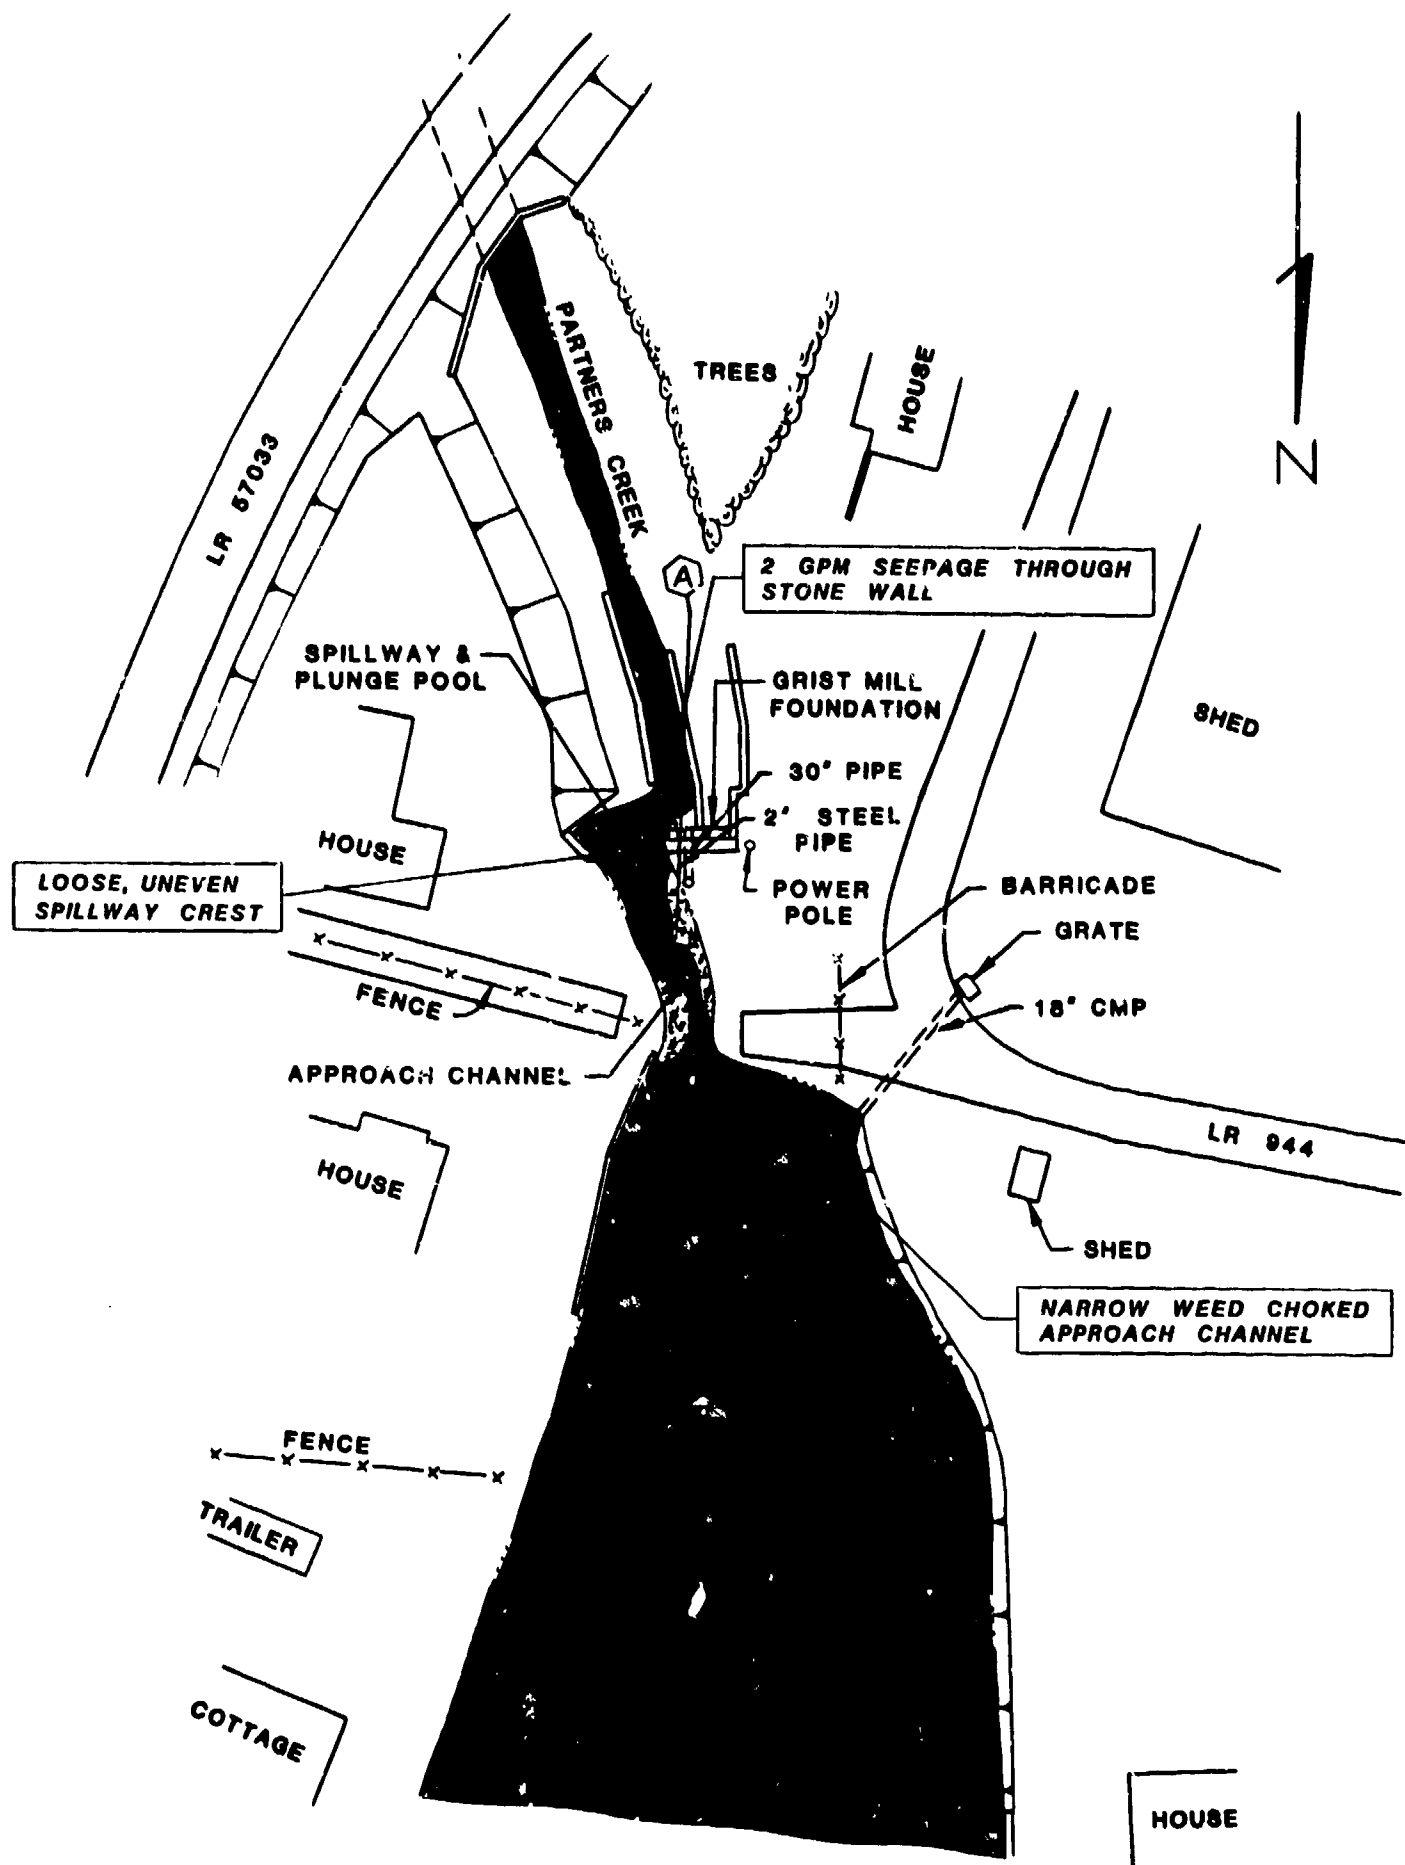
**ACRE POND DAM
GENERAL PLAN - FIELD INSPECTION NOTES**

a. General: The overall appearance of the dam is poor. Locations of observed deficiencies are shown on the General Plan presented in Exhibit A-1, Appendix A. The profile and typical sections of the dam are presented in Exhibits A-2 and A-3 and are based on field survey made on the day of inspection. The survey datum for this inspection is elevation 1203.0 feet above mean sea level, which is based on the normal lake surface elevation shown on the USGS topographic map (see Exhibit E-1). On the inspection date (7/13/1981), the lake level was at elevation 1203.5, which is the bottom of the spillway approach channel and is 0.5 foot above the low point on the spillway. Deficiencies observed during the field inspection are described below, and further illustrated in Exhibit A-1, Appendix A. Visible features are depicted in photographs, presented in Appendix C.
